Contracting/Design Innovation Report

I-40 Emergency Slide Repair

Location: I-40 Between Mile Markers 3 and 4

DESCRIPTION: This project consists of grading, drainage, paving, retaining walls and toe slope protection on I-40 in Haywood County to repair slide sites from Hurricane Ivan.

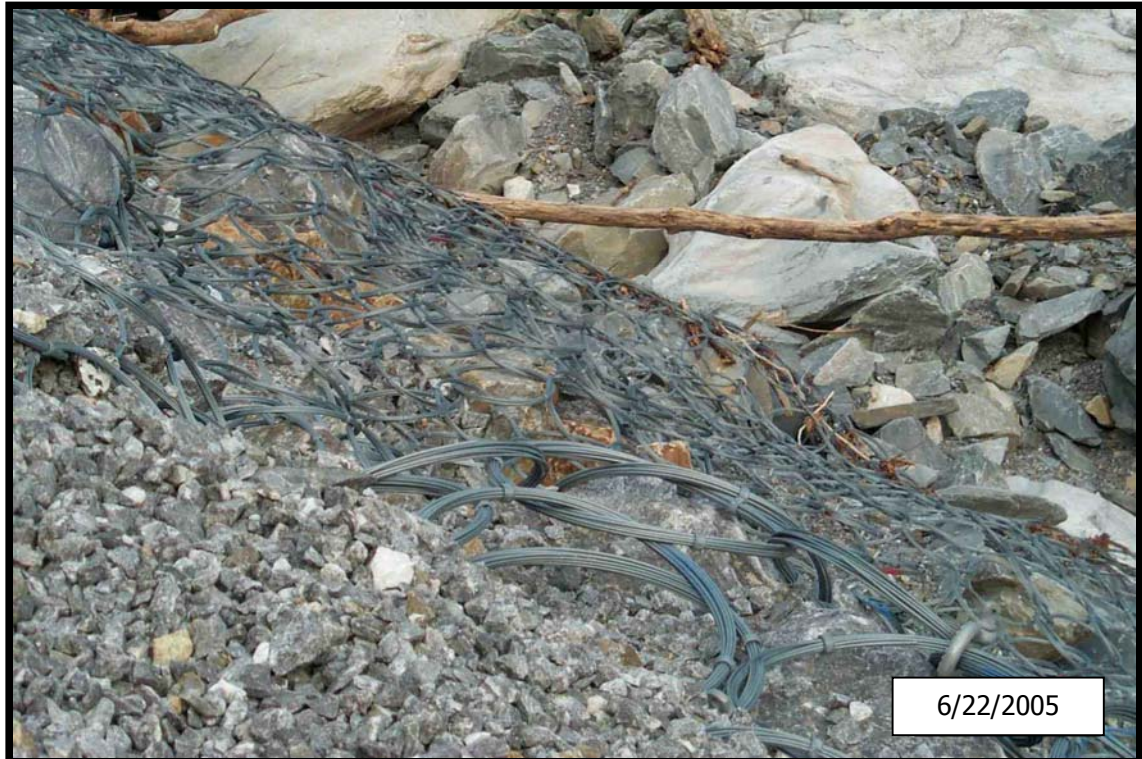
- In lieu of tensioned rock bolts, grouted rock dowels were used to hold the ring net system in place. The Contractor proposed using the grouted rock dowels for ease of construction and as a cost savings to NCDOT. The Geotechnical Engineering Unit approved the use of the dowels for this application, because the large mass of material on top of the ring net system holds it in place without anchors. Tensioned rock bolts, which are commonly specified, were structurally more than required for this use of the ring net system.

Several innovative design aspects were incorporated into this project. For toe slope protection, the Hydraulics staff needed a flexible system that could withstand impacts from boulders during future flood events. After weeks of brainstorming between the Department's Hydraulic Unit, Geotechnical Engineering Unit and Structure Design Unit, it was decided to use ring nets to hold the toe scour protection in place. These energy absorbing ring nets are traditionally used as barriers for rockfall protection. For this project, the ring nets were used to actually wrap layers of rock. The ring nets allow the system to be somewhat flexible since they are anchored into the rocks using bolts and dowels. A gabion wall system was considered but dismissed due to its' inability to withstand future storm events and the extensive time required to build the gabions.

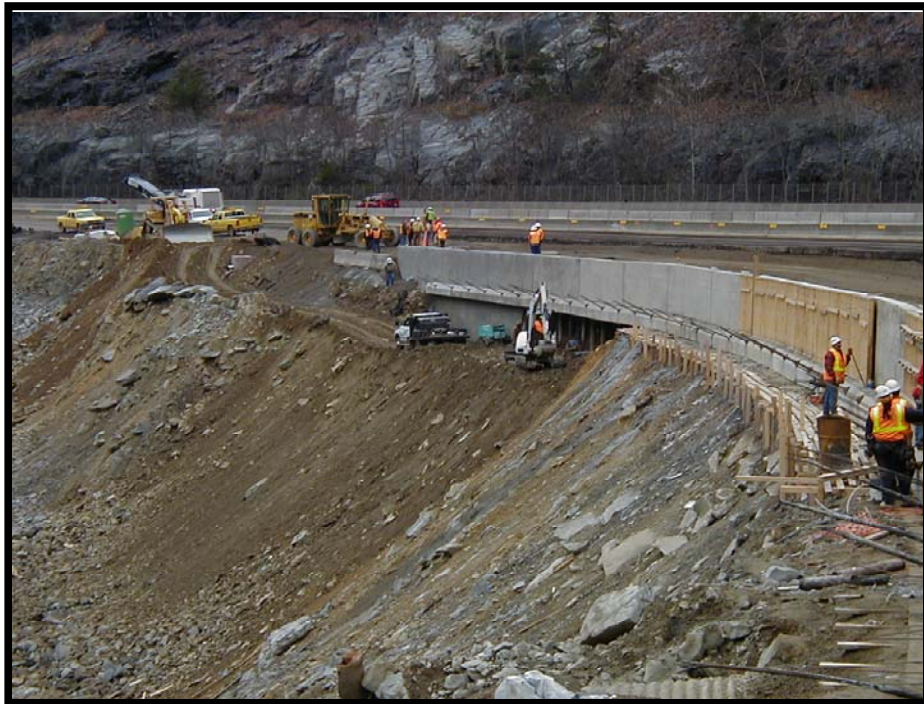
- The contractor provided contract surveying by supplemental agreement. Inspection was provided by NCDOT.
- A supplemental agreement was added to the project to repair another slide adjacent to this project. The adjacent slide (site 3) was only accessible from this project without extensive unnecessary grading. There was also no suitable staging area at site 3. The work at site 3 consisted of extending the toe scour protection approximately 625 feet. The slope was then regraded and rock-plated. No retaining wall was constructed at the third slide site. NCDOT saved money and time by including this work as a supplemental agreement.

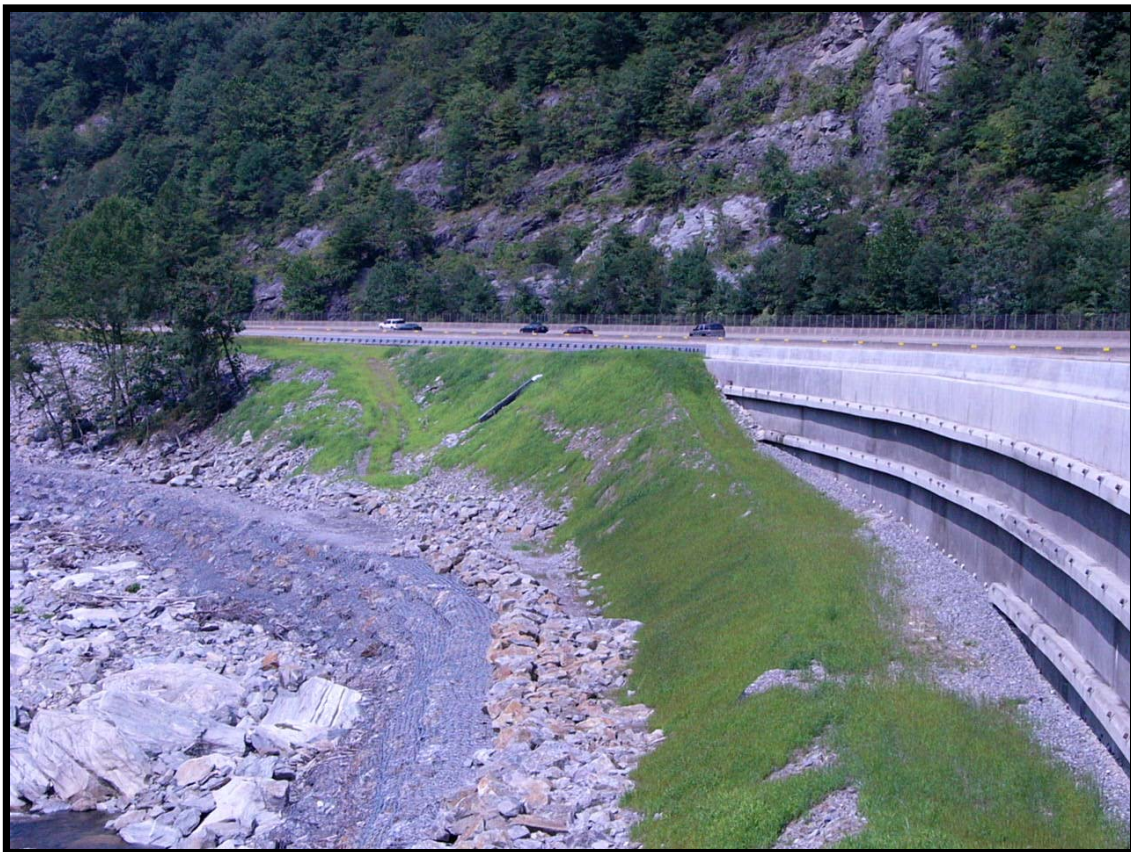
- A contract was let in June 2005 for repair of an additional slide area. Because of the relationships established and the contractual issues that arose in the previous slide repair job, this contract did not utilize a nested Design-Build concept. This contract allowed submission of a wall design paid for by a generic wall pay item. The geotechnical subcontractor on this project is Hayward Baker. Their design utilizes a precast wall. The wall uses 24" steel pipe piles (in lieu of H piles with casings) filled with concrete, with welded lagging, timbers and precast panels.
